TECHNICAL INFORMATION SERIES

AUTHOR <i>W. D. Simpson</i> W. D. Simpson		SUBJECT CLASSIFICATION Failure Analysis		NO. 66SD281	
				DATE August 6, 1966	
TITLE FINAL REPORT - FAILURE ANALYSIS AND DESIGN REPORT OF NIMBUS I SOLAR ARRAY DRIVE FAILURE					
ABSTRACT The Nimbus I Weather Satellite failure was investigated by analysis and laboratory tests. The failure was found to be due to deterioration of the grease in the Solar Array Drive motor bearings due to high (>300F) temperature conditions. Corrective design changes lowered temperatures to less than 200F; subsequent laboratory and flight tests have been successful.					
G.E. CLASS II		REPRODUCIBLE COPY FILED AT MSD Documents Library;Valley Forge STC;PO Box 8555; Phila.,Pa. 19101			NO. PAGES 63
GOV. CLASS. Unclassified					
CONCLUSIONS 1. The Nimbus I flight failure was induced by high temperature(greater than 300F) conditions in the Solar Array Drive Motor bearings. The high temperatures caused deterioration of the G300 silicone grease lubricant,increasing motor bearing friction and producing motor stall. 2. The high temperature condition was a design and operating characteristic and was not caused by variabilities or anomalies. 3

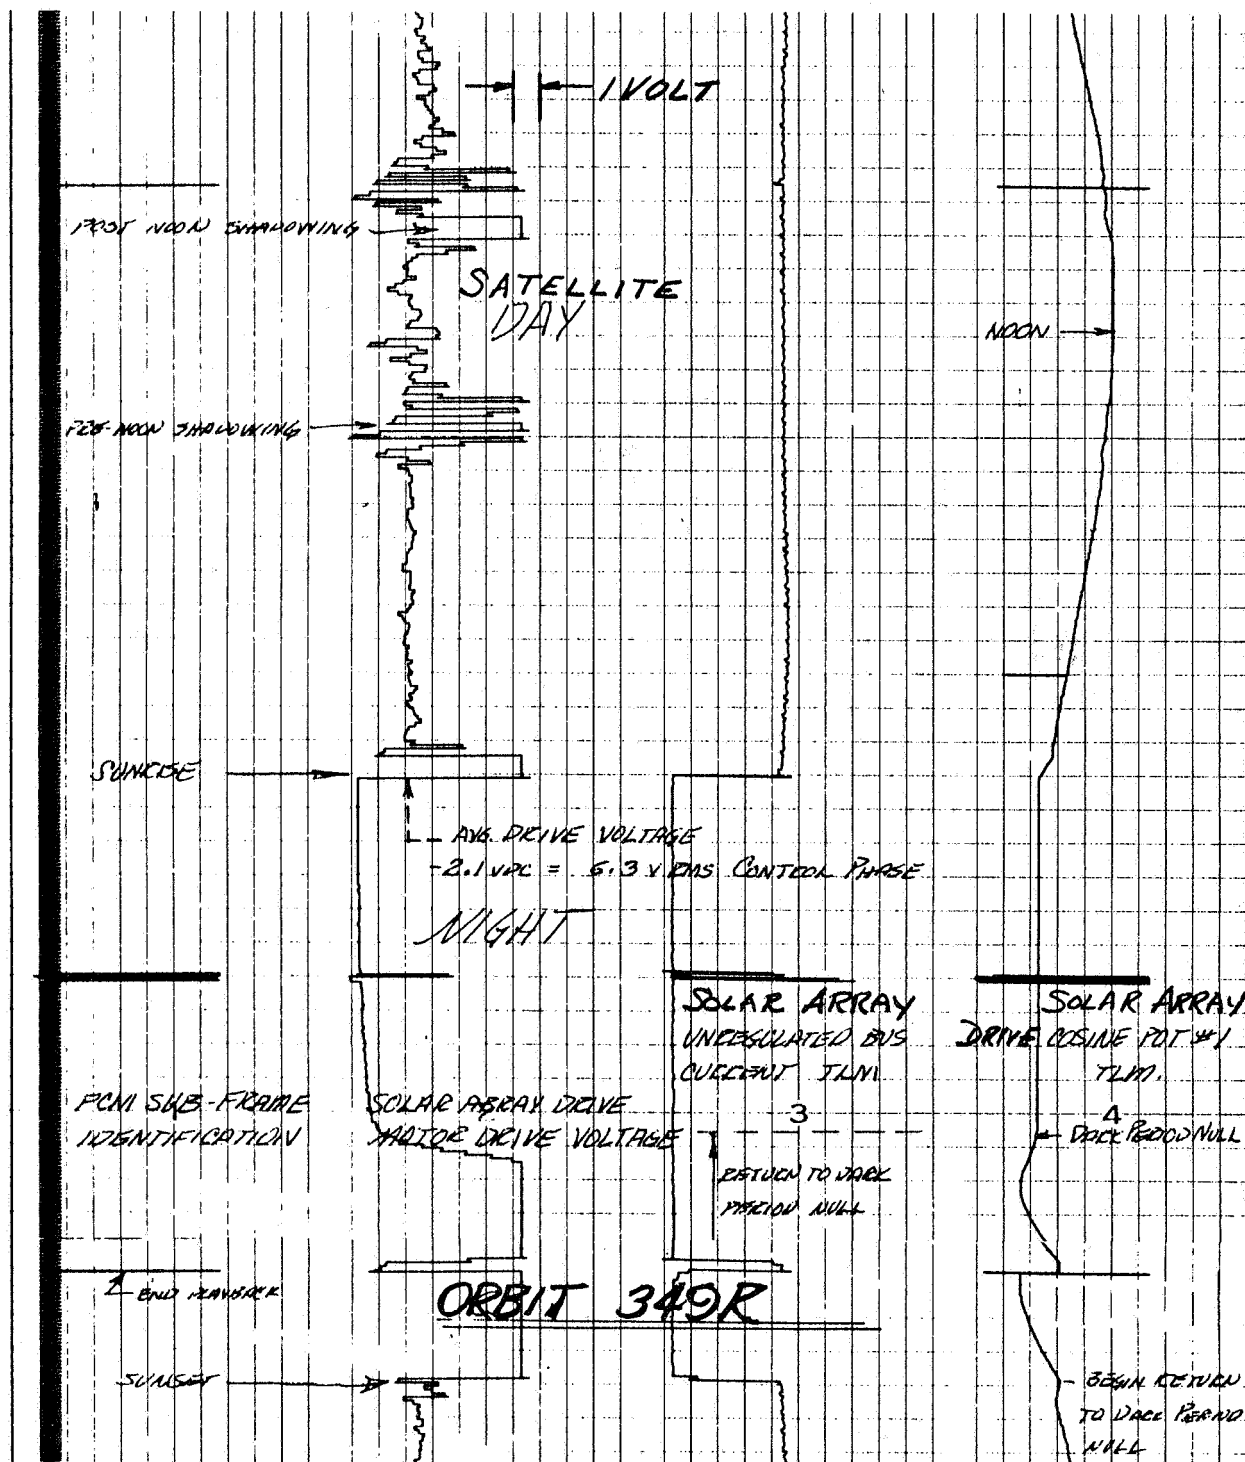
Section 3, Figure 6
Solar Array System TLM, Orbit 349

Figure 6 shows the operation of the Solar Array Subsystem 20 orbits before final failure. During the satellite day, the average voltage necessary to track the sun has risen from the early value of about 1.5 volts (TM) to about 6.3 volts (TM) and is quite erratic. This effect is very pronounced at the pre- and post-noon shadowing. (Note the change in scale between Figure 5 and Figure 6.)

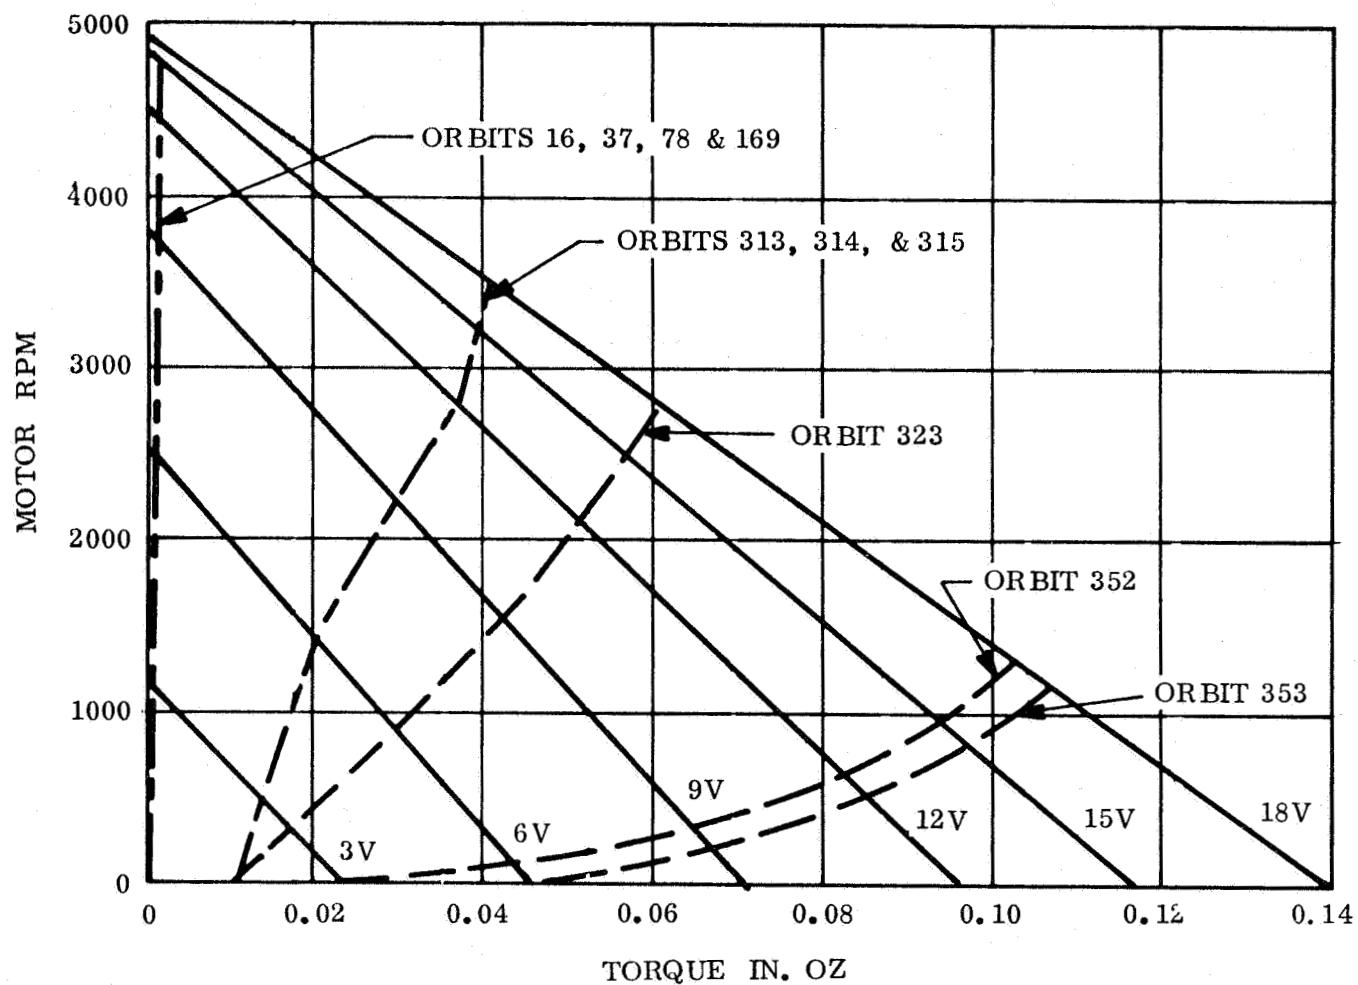
Section 3, Figure 11
Solar Array Drive Motor Speed.
Orbital Data Superimposed

The data for a number of representative orbits are shown in Figure 11. Note that the lines shown connecting the data points for each orbit are not lines of constant torque but rather represent the operating line as the drive saw varying torque load with speed changes. From Figure 11, it is evident that the load seen by the Solar Array Drive motor increased steadily. This appears to be indicative of increased friction due to gradual wear, binding, loss of lubrication or from contamination.

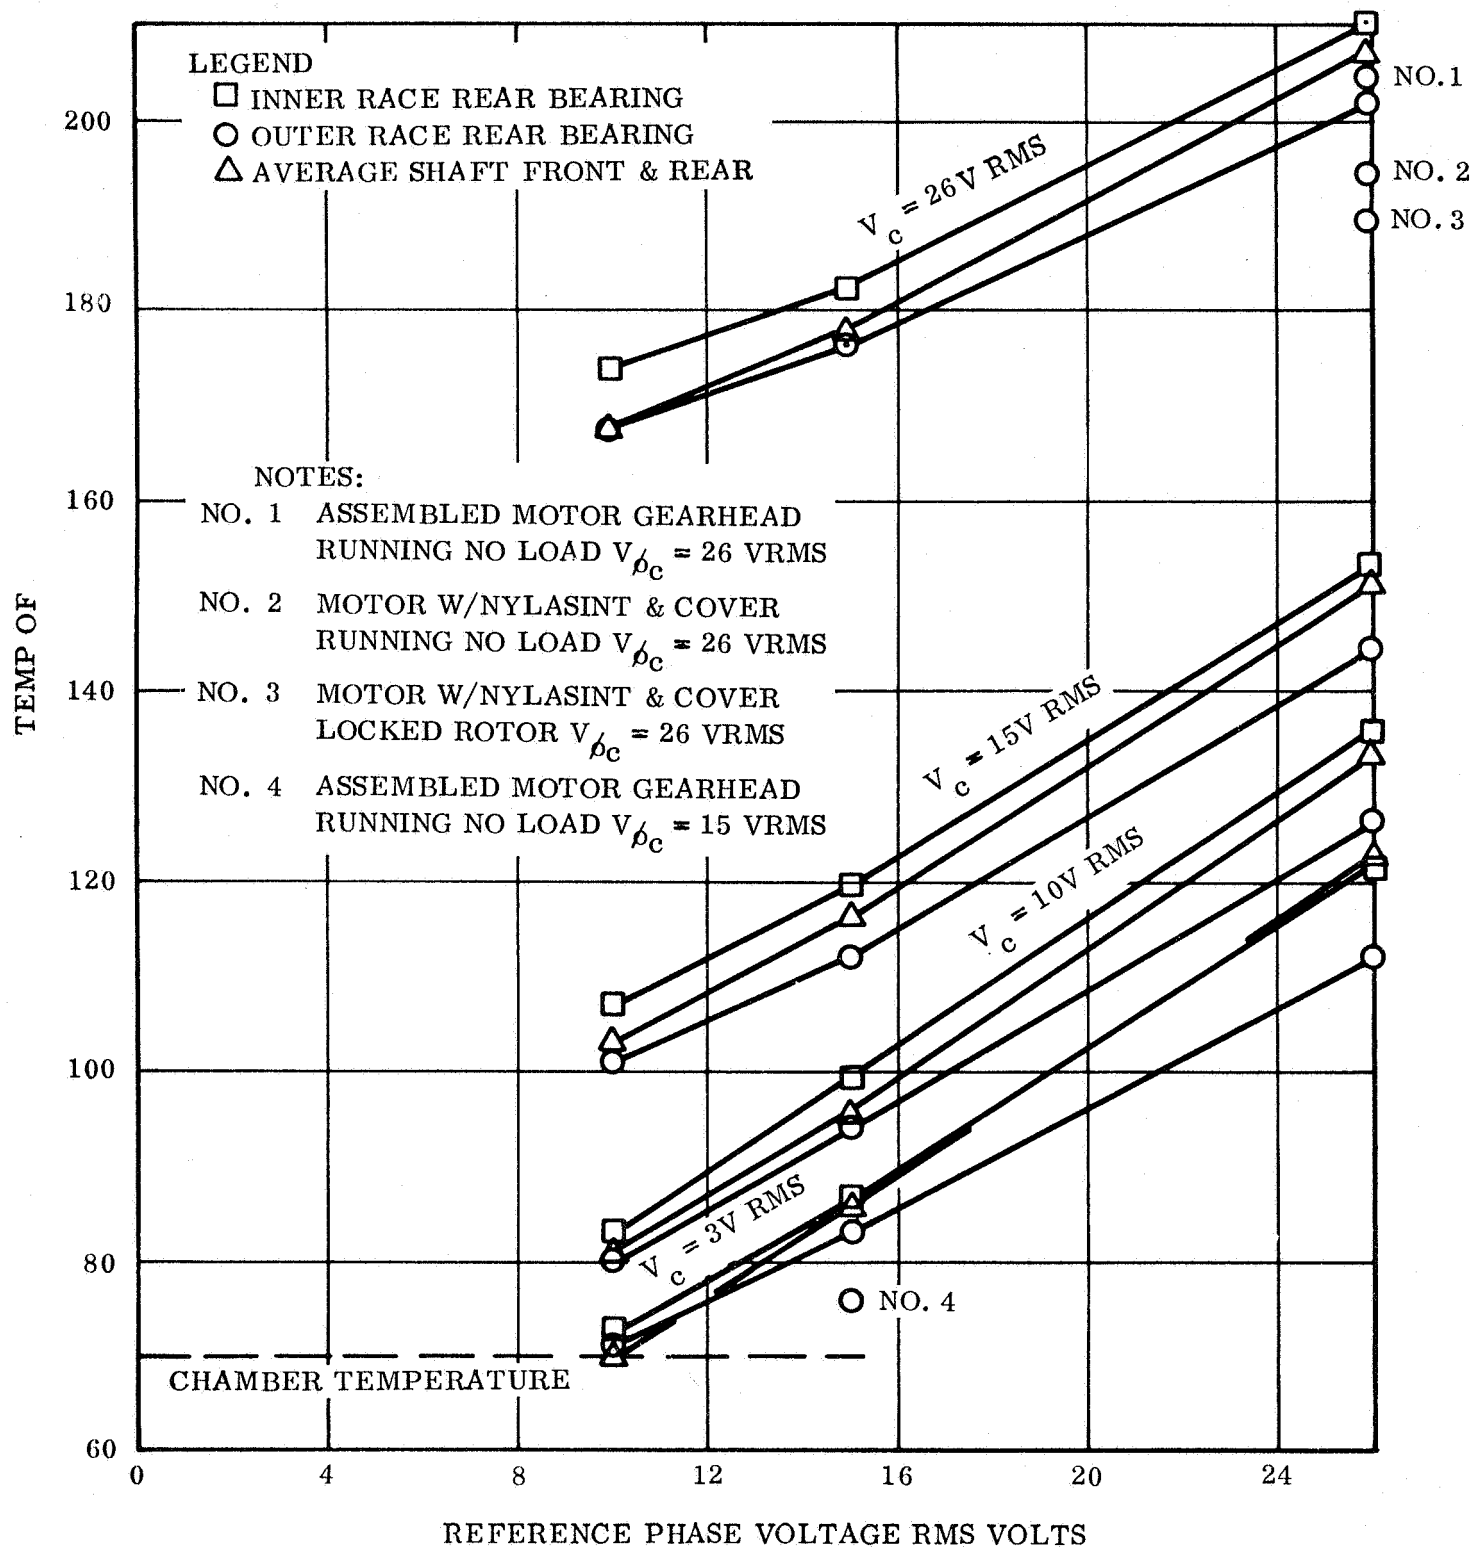
Section 3, Figure 13
 Motor Gearhead Temperature Rise in Vacuum

Figure 13 shows the temperature rise in vacuum of the hottest measured points on the motor, both stalled and running. Figure 14 shows the thermal response of selected points on the motor for both power-applied and power-removed conditions. The thermal time constant is approximately twelve minutes.

Under slewing rate conditions with maximum power input and the highest control box ambient temperatures, the data indicated that the motor bearing local temperatures would not have exceeded 210°F. Based on the published data for G300 grease, this temperature was not high enough to have caused serious degradation of the lubricant. However, it was realized at this point that the actual operating rotor temperature might be greater than that indicated by the tests and that the G300 grease might have lower temperature limitations than data to date indicated, and therefore lubricant deterioration was still a distinct possibility.
